FANNON, BRIAN R., PhD. Beaver Dam Features Influencing Stream Channel Form in the Mountain and Piedmont Physiographic Provinces of North Carolina (2015)

BEAVER DAM FEATURES INFLUENCING STREAM CHANNEL
FORM IN THE MOUNTAIN AND PIEDMONT
PHYSIOGRAPHIC PROVINCES OF
NORTH CAROLINA

A Dissertation Submitted to
the Faculty of The Graduate School at
The University of North Carolina at Greensboro
in Partial Fulfillment
of the Requirements for the Degree
Doctor of Philosophy

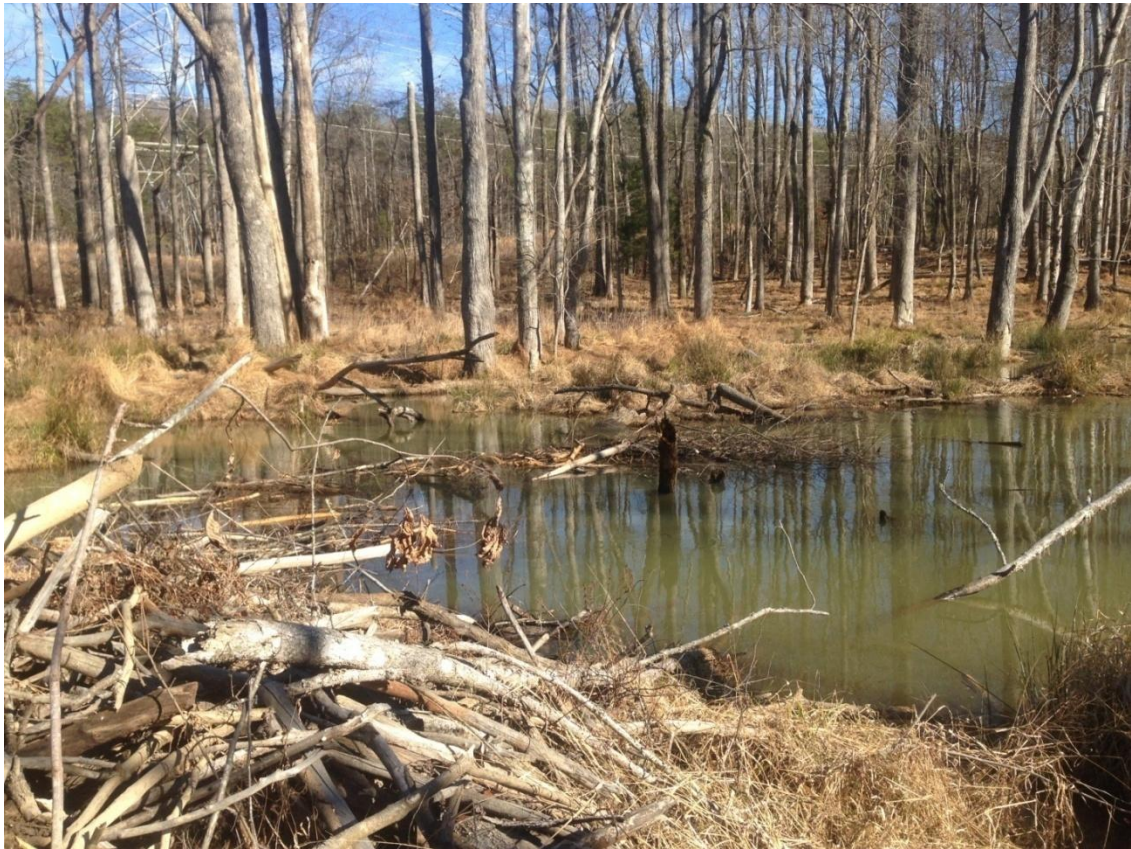
many check dams have been incorporated into primary dams as water levels have risen, leaving the primary dams traveling in a meandering path between shorelines, and increasing the dam length beyond a simple straight-line measure between shores. This site is also rich in large woody debris, both as a direct result of beaver cutting, and as a result of trees killed by inundation and falling into the water, and a great many trees remain standing deadwood, ready to contribute LWD for many years. Figures A43 and A44 provide an example of the rich assemblage of woody material collected in this complex of dams.

Figure A43. A Variety of Woody Debris at Site P3. (Author)

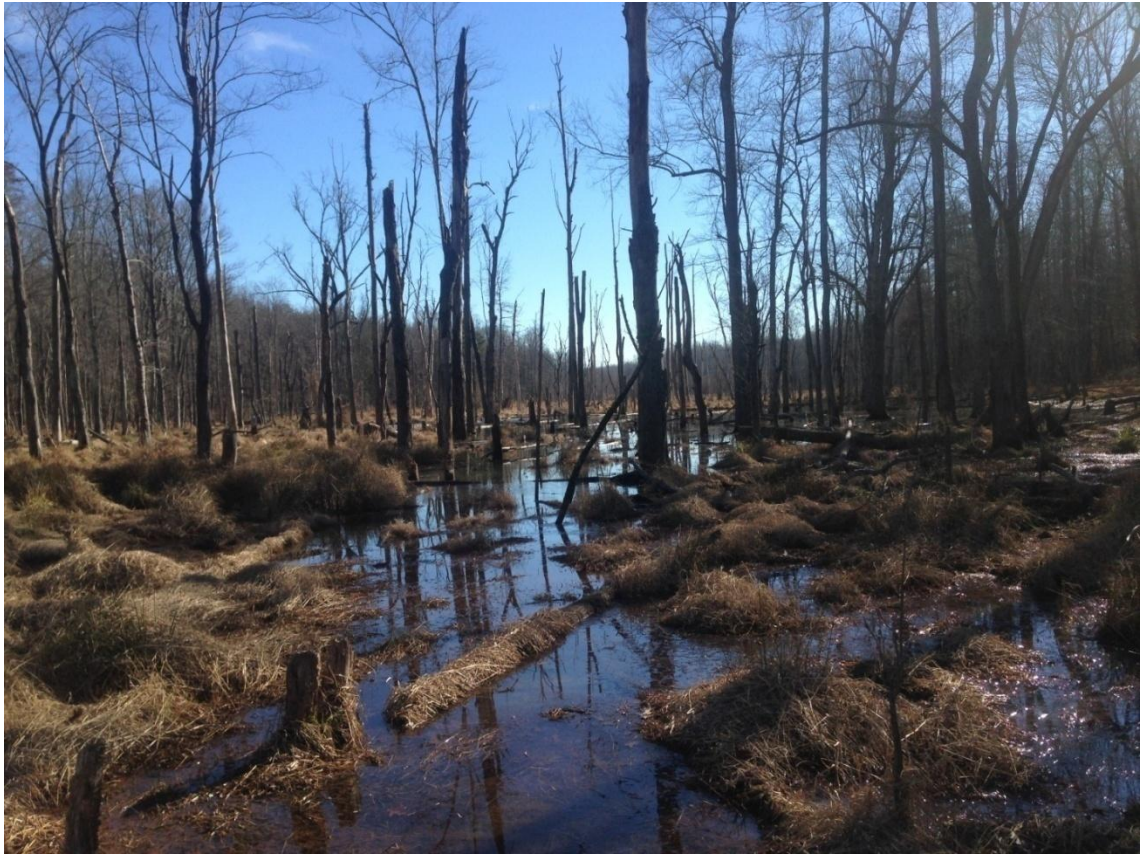
Figure A44. Another View of the Woody Debris at Site P3. (Author)

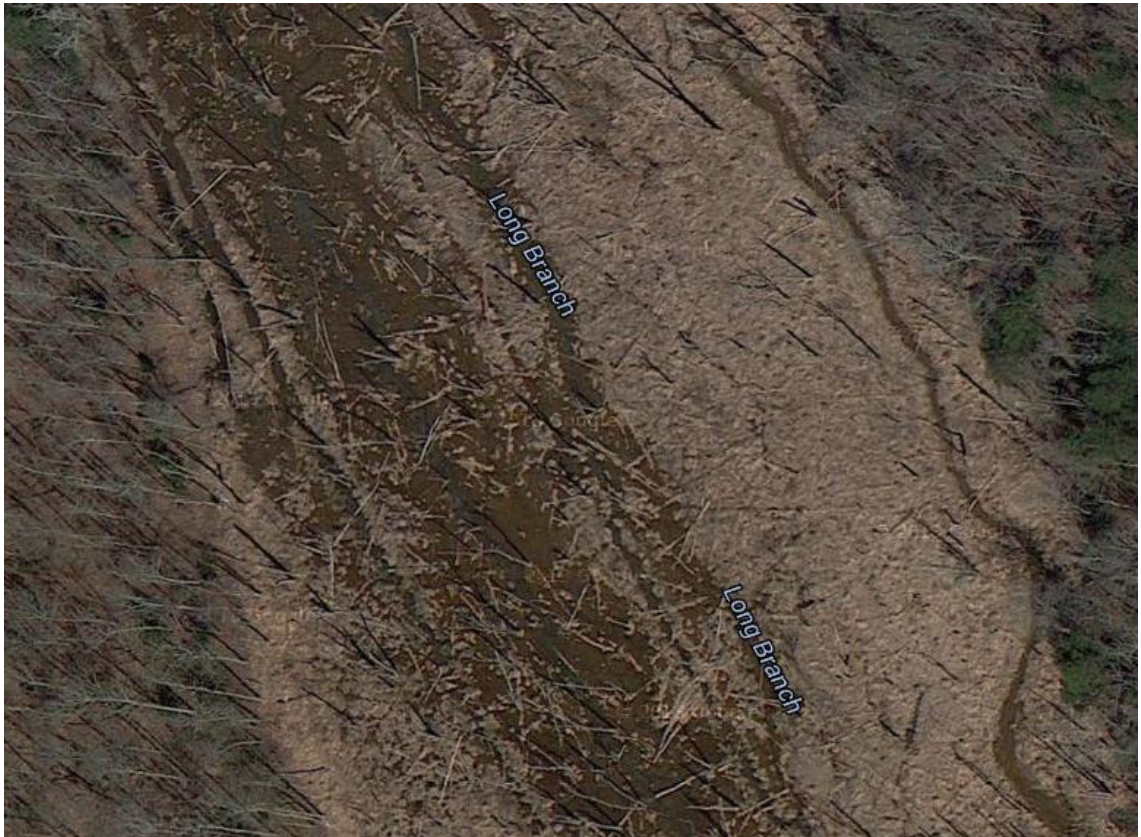
Anabranching was very clear in aerial photos of this site. Spacing between dams provided extensive saturated soils, and long (100m+) dams provided numerous outlets for water. The upper area (Figure A45) contained three long (200m+), separate channels through the potential meadow area, while one of the lower areas contained at least ten separate channels (Figure A46). Nearly all channels in this complex carried water, as opposed to site M3 where several

Figure A45. Upper Area of Site P3, showing multiple channels. (Google Earth)

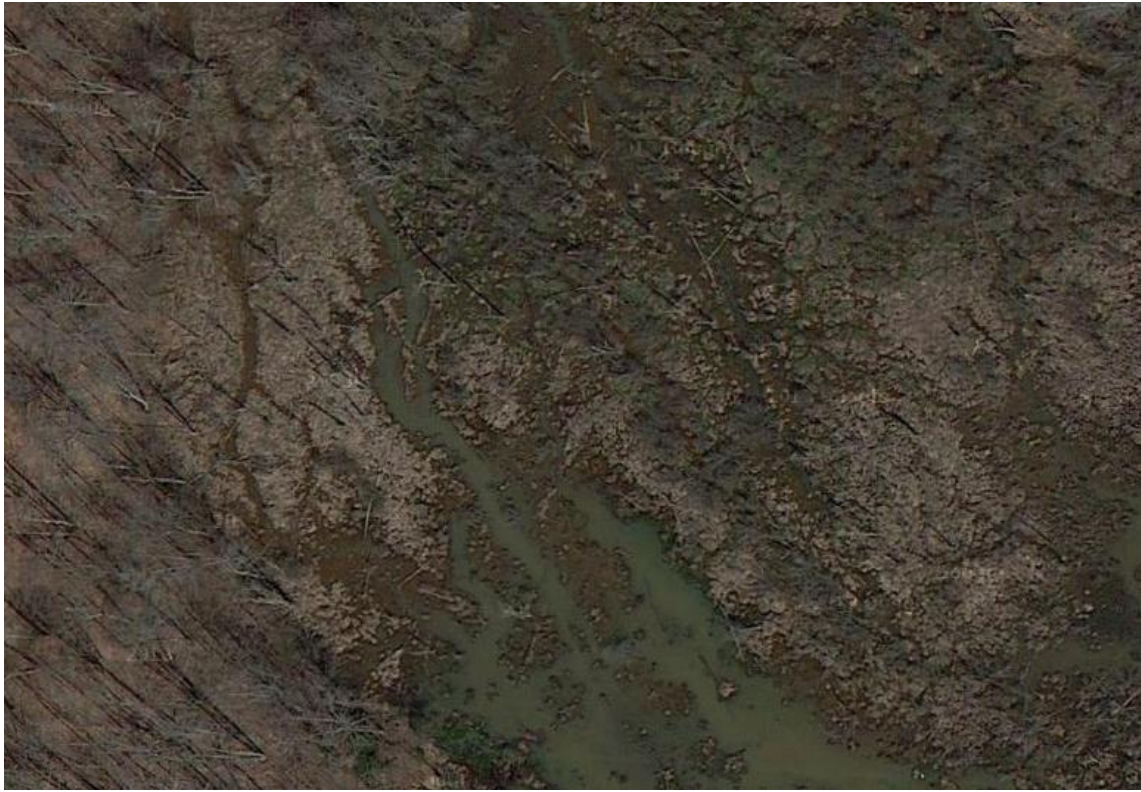
Figure A46. Lower Area of Site P3, showing Complex Anabranching Channel System. (Google Earth)

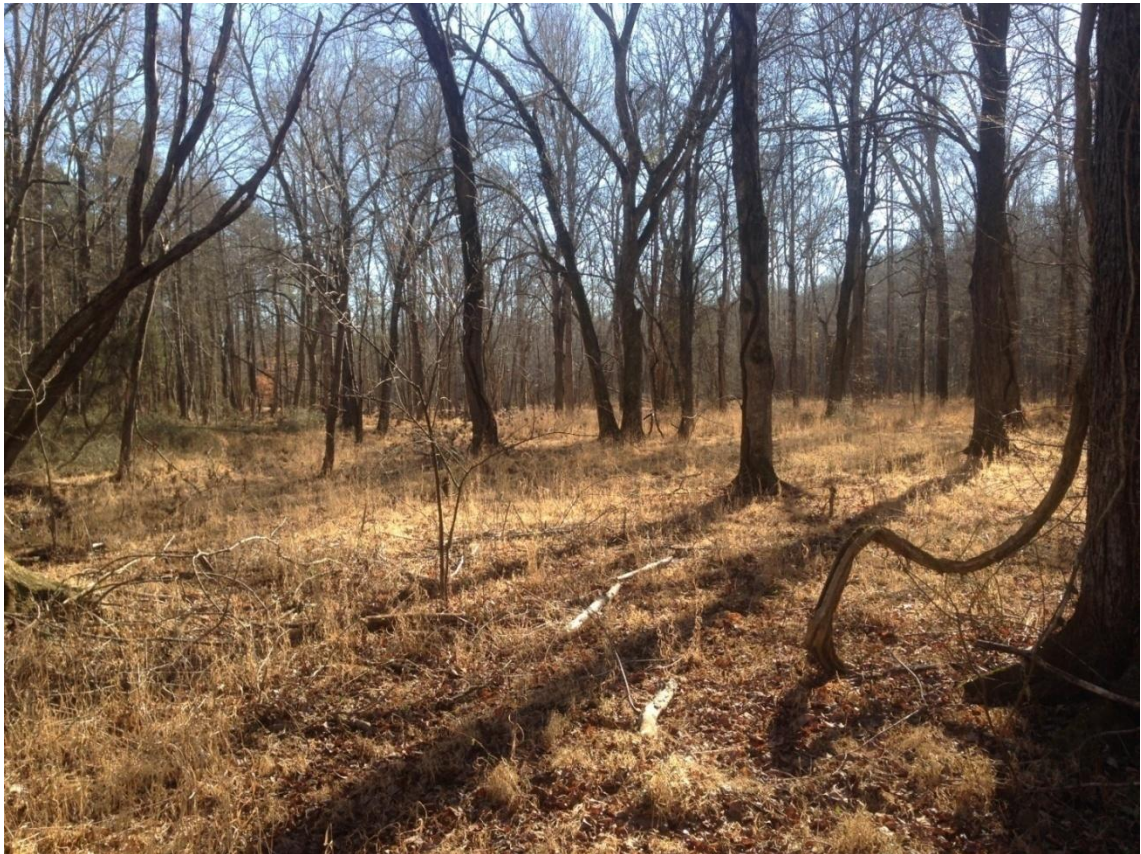
This site also had remains of an earlier, failed, dam just upstream of the last active dam. Waterlines on trees remained, indicated a depth of approximately 1m above the forest floor, and built in a slightly incised (75cm) stream channel. The pond had covered approximately 1,200m² area, and several woody food discard piles were present across the forest floor, along with several larger (3m+) tree trunks and dam remains. The reason for abandonment is unknown, but may have been due to dam loss in the early building stage due to a high flow event. The remaining standing trees had survived, indicating a short period of inundation, but the area was conspicuously devoid of small (<5cm

diameter) trees, as shown in figure A47. The surrounding forest, including the area just upstream of this location, have considerable small tree and shrub growth, indicating that those plants were lost when the beaver initially colonized this area and have not regrown.

Figure A47. Previously Flooded Area in Upper Section; note Lack of small Trees and Shrubs. (Author)

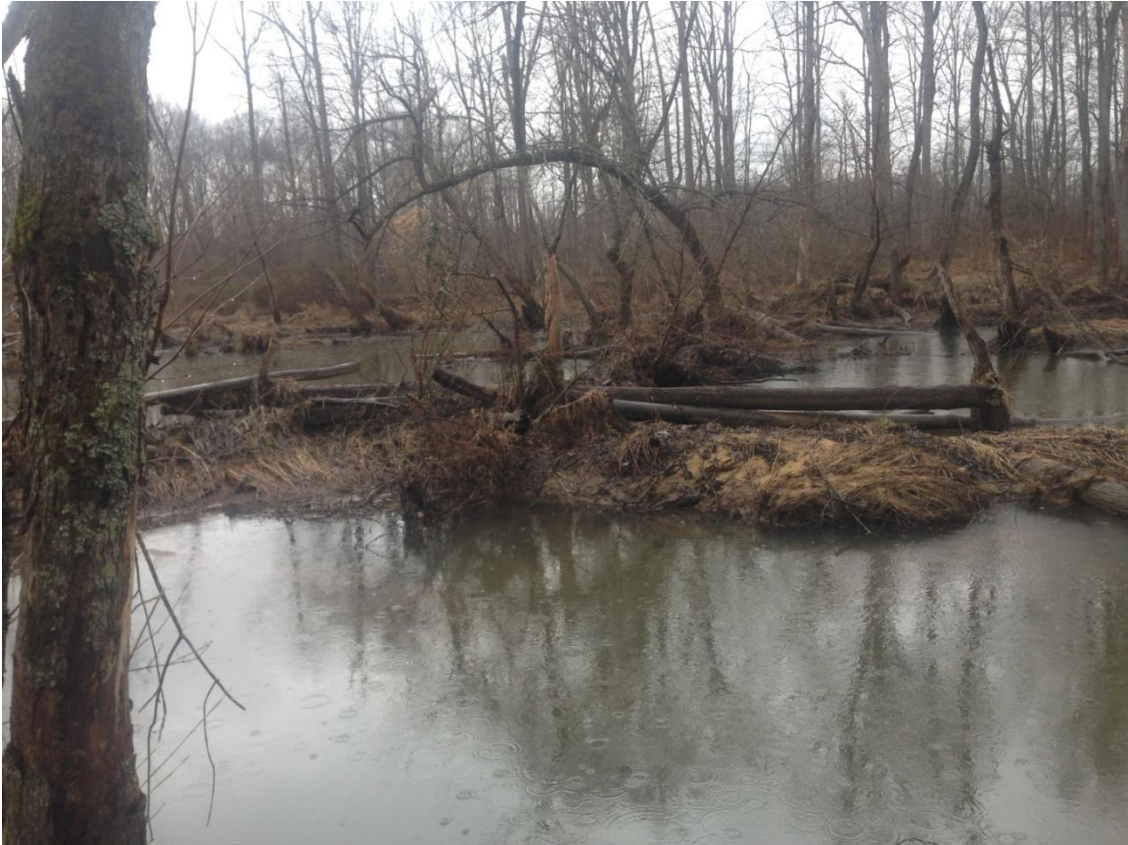
sparser and larger (figure A49.) Fewer patches of small woody debris (<5 cm) were noted, but multiple channels, inundated areas, sediment accumulation, and terrain prevented a thorough examination of some areas of this site.

Figure A49. Woody Debris at Site P4. (Author)

This site involved a complex of 5 main dams and 8 check dams, impacting a 1,100m reach of Big Alamance creek upstream of a disused mill dam. Woody debris accumulation was similar to site P3, though LWD tended to be both

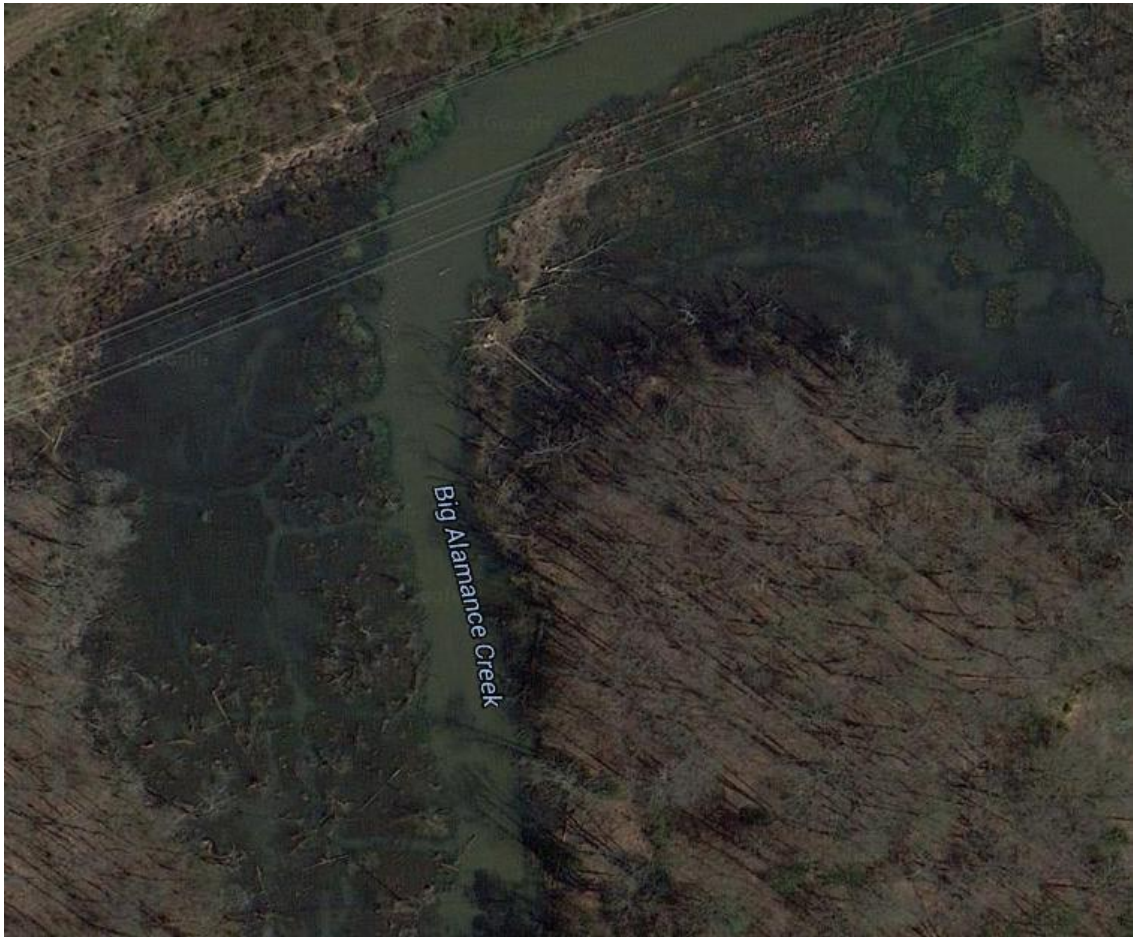
Anabranching took two forms at this location; the first being smaller channels similar to P2 and P3 (figure A50), the second much larger (figure A51.) The smaller channels ranged from .5m to 2m, and were located primarily in waterlogged soils with limited terrestrial vegetation for stabilization. As this was an active site, no ephemeral channels were noted. The larger channels, ranging

Figure A50. Small Anabranching Channels Connected to Main Channel, Site P4.
(Google Earth)

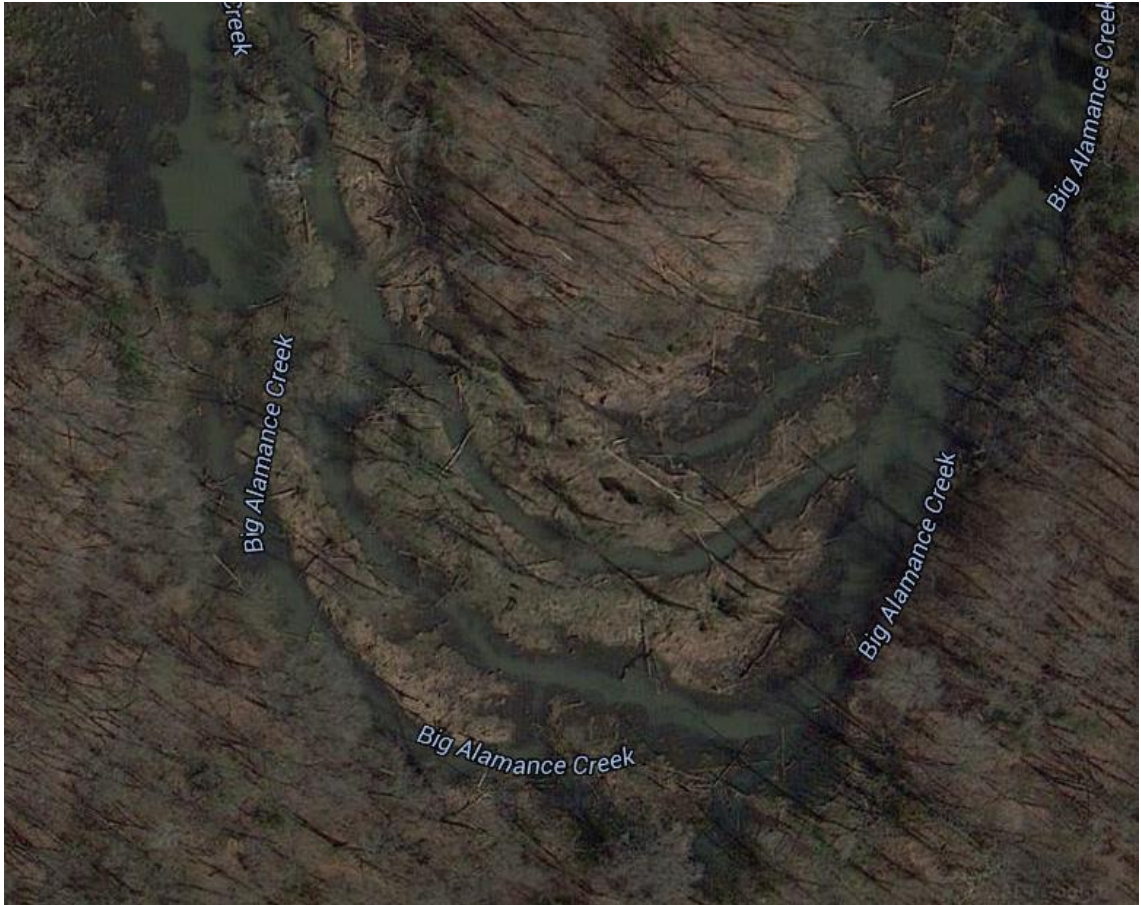
from 3m to 6m in width, were located in a more stabilized area, with non-inundated soils and substantial vegetation (including some woody shrubs and resprouting trunks) acting to stabilize areas between the channels.

Figure A51. Large Anabranching Channels, Site P4. (Google Earth)

Several old dam sites were identified, indicating that this location had been used more than once by beaver, and a probably predate the current activity by many years. Aerial photos as early as 1999 (Figure A52) clearly show the large anabranching channels also shown in figure A51. These channels remain stationary from that point onwards, though clear signs of the current beaver activity only begin to show up on aerial photos in 2008 (figure A53.) Further investigation of these channels might determine a precise origin, but the evidence of old dam sites provide a strong case for beaver-related origins.

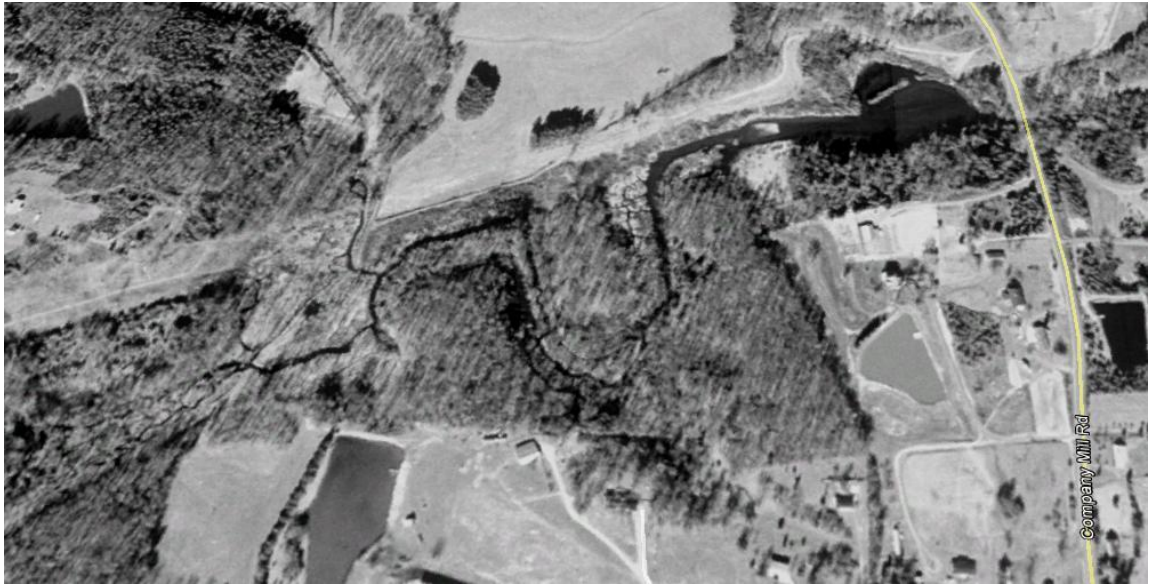
Figure A52. 1999 Aerial Photograph showing Anabranching Channels in Lower Center. (Google Earth)

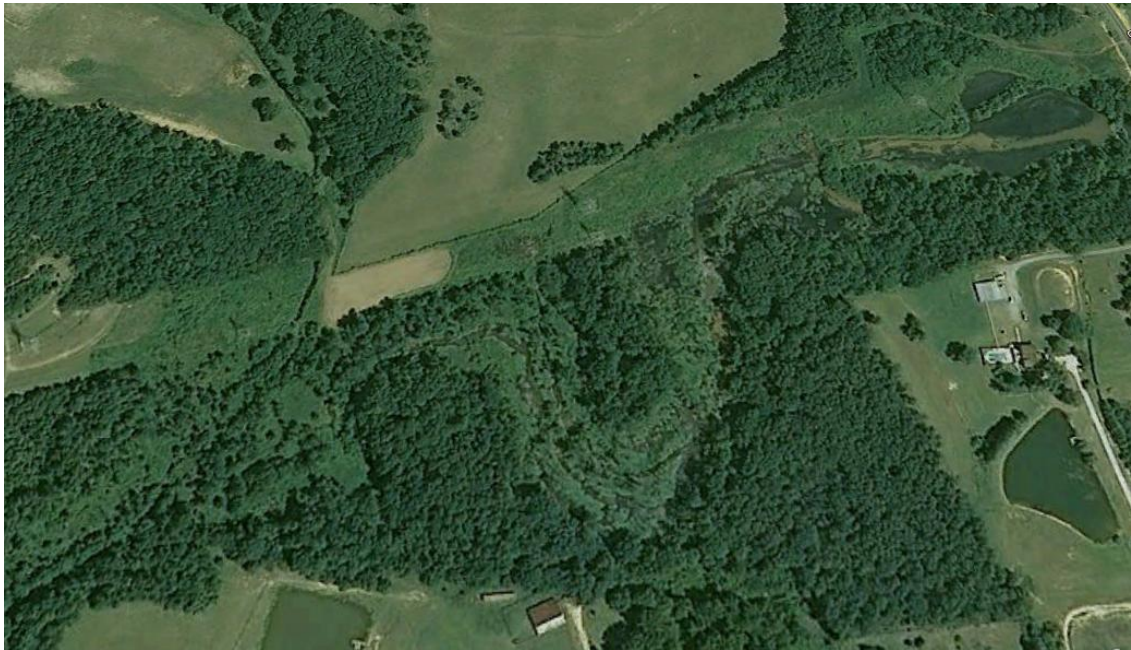
Figure A53. 2008 Aerial Photograph, showing Beaver Activity in Upper Right Center. (Google Earth)
